Customer Satisfaction Campaign 450: Replacement of Fifth Bow Latch Motor Assembly

MI No. 811-1758

Date June 1997

PI No. 5/97 Grupp 8 D 3.0

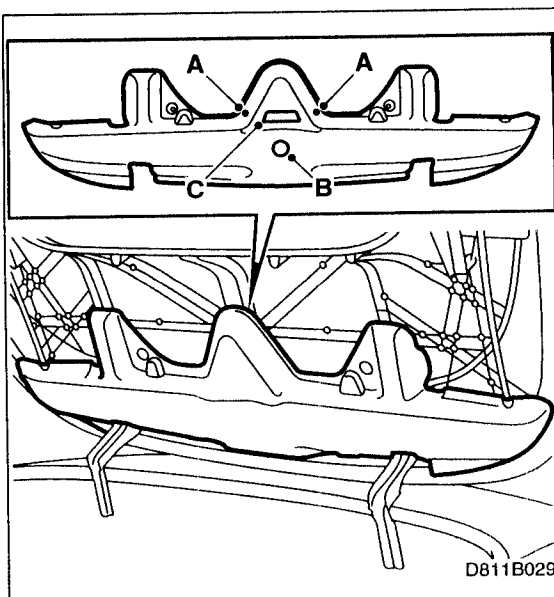
First check whether the motor cover panel is fitted with two Torx screws(A) and that a plastic plug (B) and tape (C) are fitted to the cover panel. If the bolts or plastic plug are not fitted, proceed as described below.

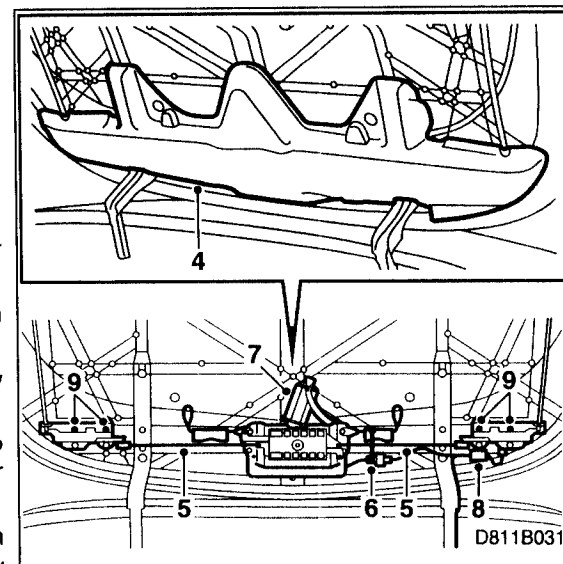
Each locking mechanism is held together using two plastic shouldered pins, P/N 74 97 910 and four white plastic washers, P/N 74 97 928 (2 per pin).

The plastic pins may in some cases be broken from use or may be damaged upon removal. They should not be required to upgrade most cars if the original press/speed nuts are cut off as instructed.

- 3 Protect the rear window and trunk lid. Insert protection under the Tonneau cover as the motor can easily drop onto the trunk lid.
- 4 Remove the cover panel.
- 5 Remove the locking rods.
- 6 Cut the cable tie holding the wiring harness and separate the connector.
- 7 Remove the four mounting bolts on the latch motor and lift out the motor.
- 8 Separate the microswitch connector on the left latch mechanism. Cut the cable tie.
- 9 Remove the two lock mechanisms for the fifth bow and place them on a work bench.
