Saab 93 Control Knobs breaking due to several issues

Procedure

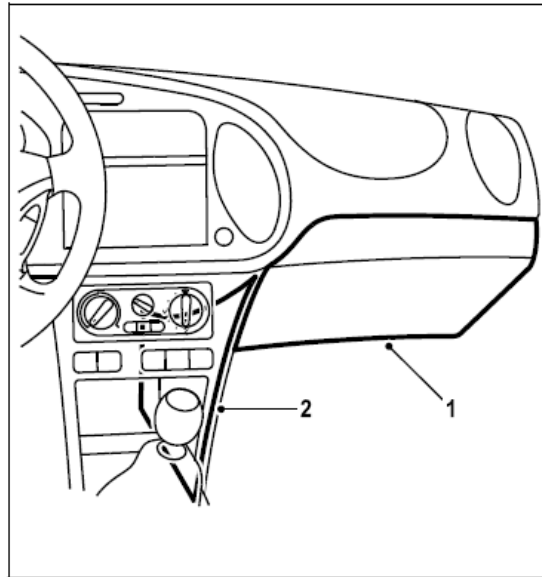
- 1 Remove the glove box.
- 2 Remove the center console side panel.
- 3 If necessary, remove the knee shield stay.

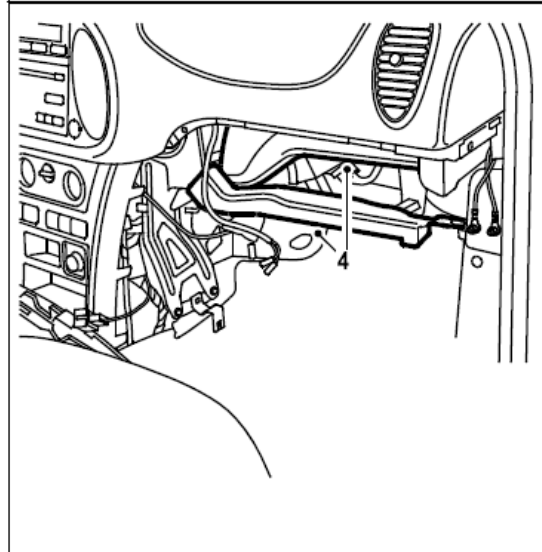
- 4 Remove the air ducts.

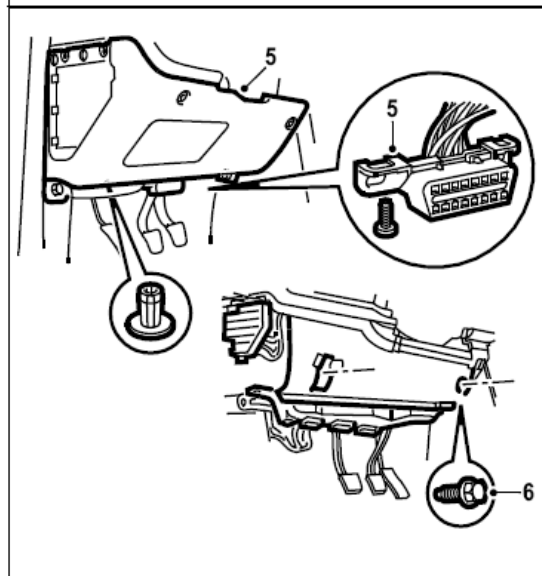
- 5 Remove the data link connector and the lower dashboard section on the driver's side.
- 6 Remove the knee shield on the driver's side.

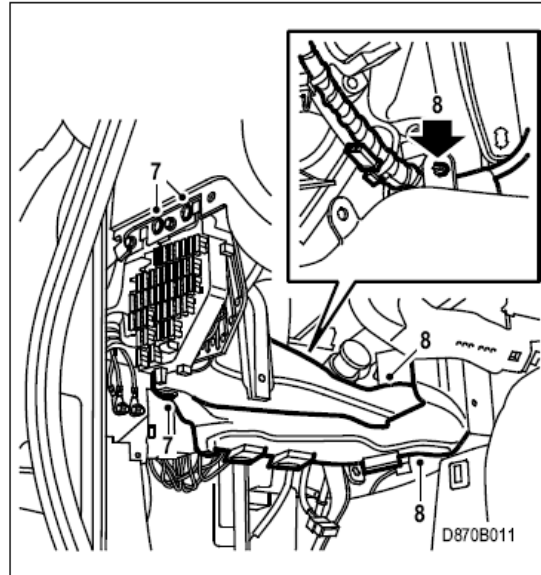
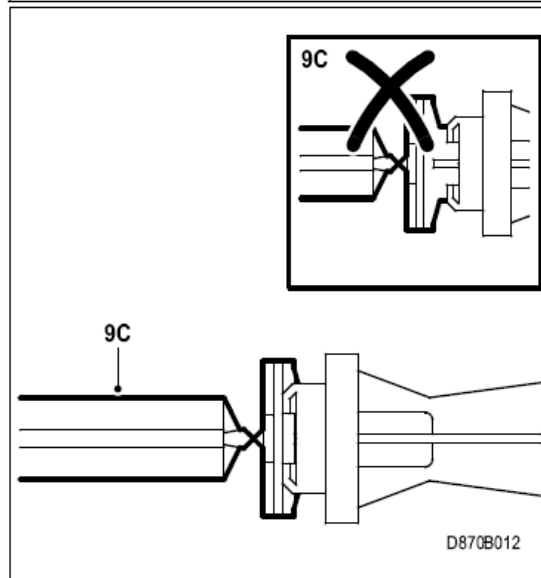
- a that the temperature control knob is not damaged or difficult to move and that the temperature control cable is not difficult to move. Replace the temperature control knob if necessary, see the following method description for "Replacing temperature control knob and shaft". Check the temperature control cable by disconnecting the cable from the lever and turning the temperature controls. If the knob is difficult to manoeuvre, replace if necessary, see WIS - 9-3 - Body - MCC - Adjustment/Replacement - Control cable. Fit the cable to the lever.

- b that the air distribution control knob functions satisfactorily. Replace if necessary, see the following method description "Replacing the air distribution control knob shaft".

- c that there is no play with regards to the telescoping air distribution control shaft in relation to the knob and that it is properly pressed into the heating and ventilation unit. Replace if necessary, see WIS - 9-3 - Body - MCC - Adjustment/Replacement - Control shaft.

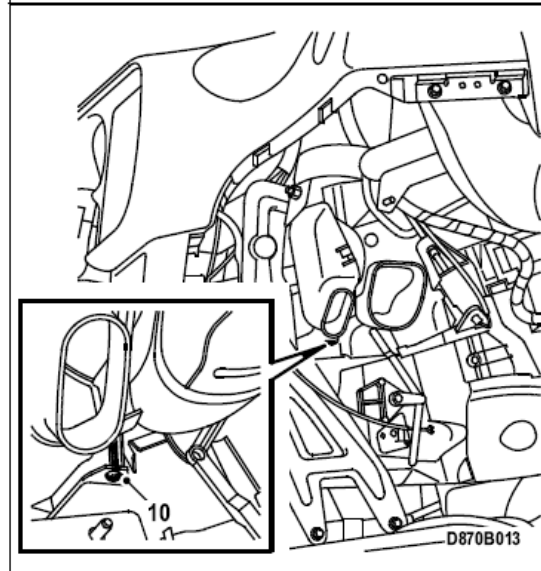
10 Remove the screw on the right-hand side.

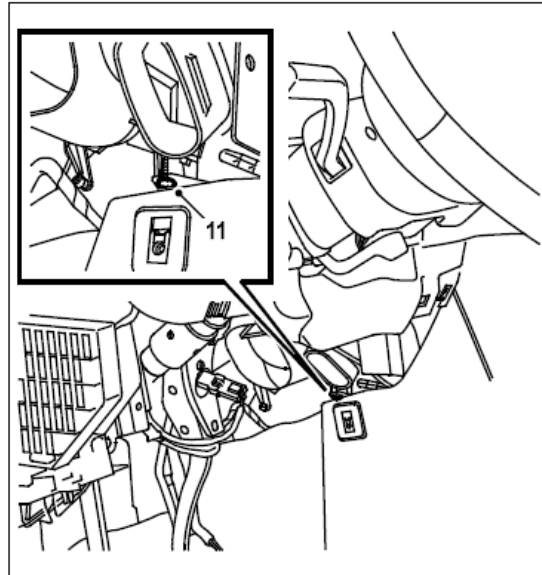
11 Remove the screw on the left-hand side.

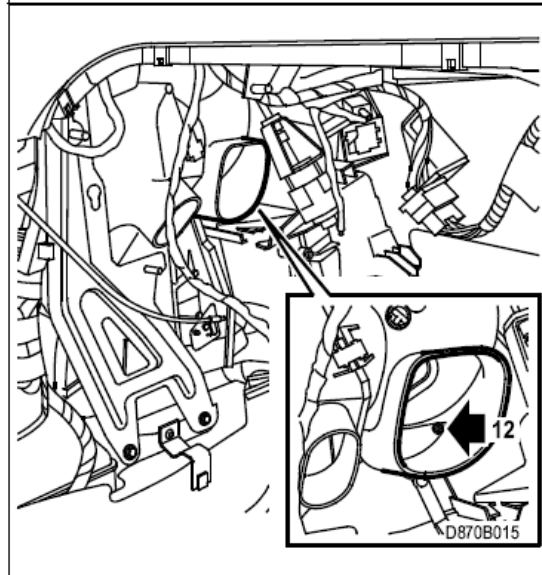
12 In those cases where the car has been previously modified with screws as shown in the illustration, remove the screws and seal the holes with sealing compound 92 88 127 on both sides.

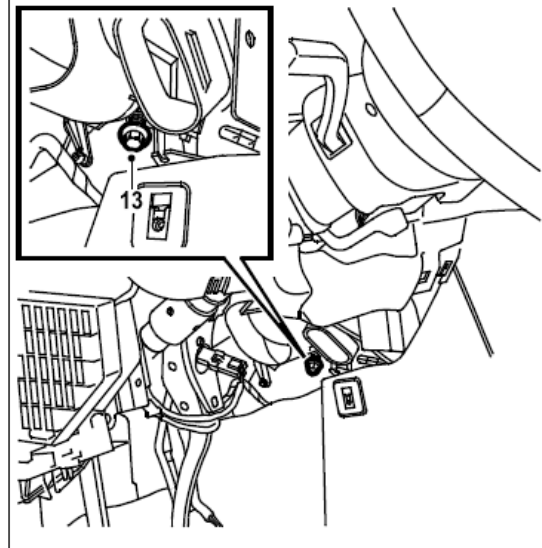
13 Fit the new screw 79 76 897 on the car's left-hand side.

The screw may be inserted and tightened to a maximum of 10 mm so as not to damage the threads created in the heating and ventilation unit.
